UHV leakage problems with the new EBS-ESRF-BPM buttons

ESRF-EBS

Extremely Brilliant Source

BPM-button vacuum leaks

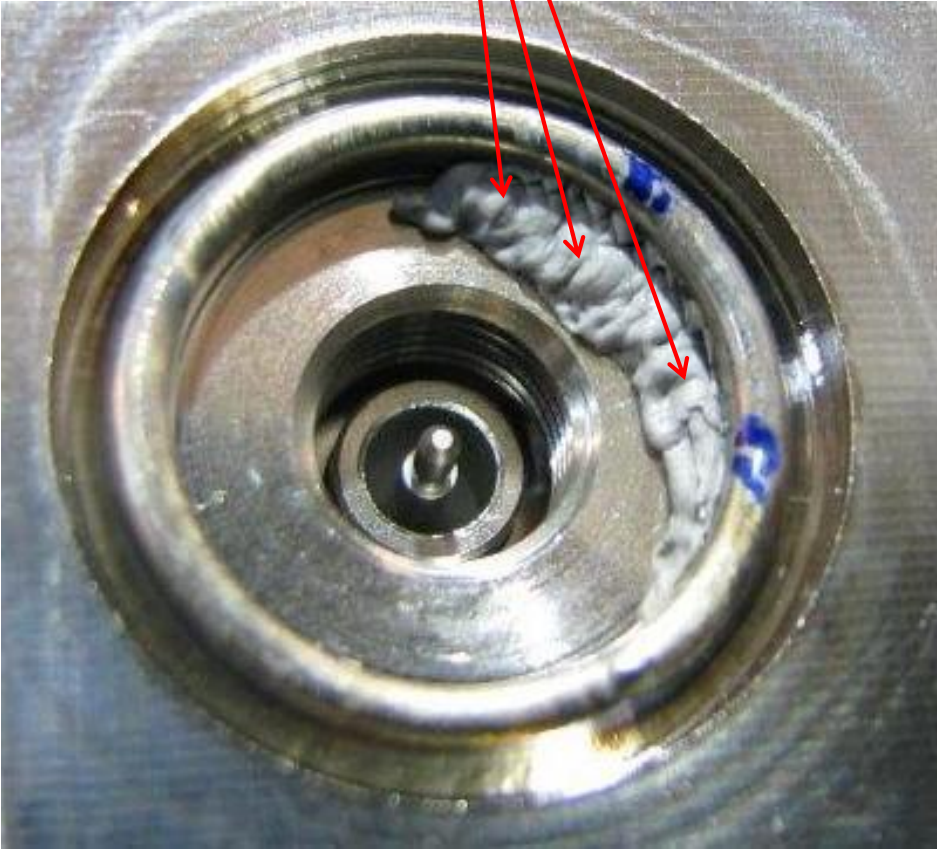
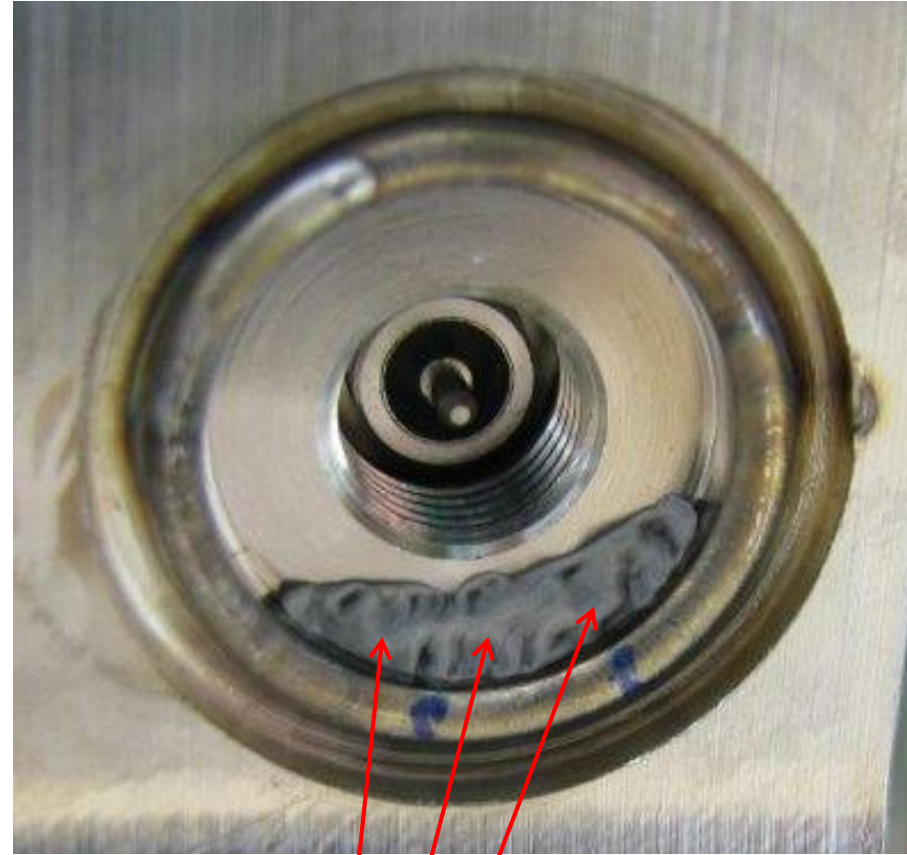
vacuum wax applied : the leak is stopped !

the vacuum wax is applied in the corner, i.e. between
the transition of the lip & the main body,
the leak (fracture) must be situated there, not on the welding

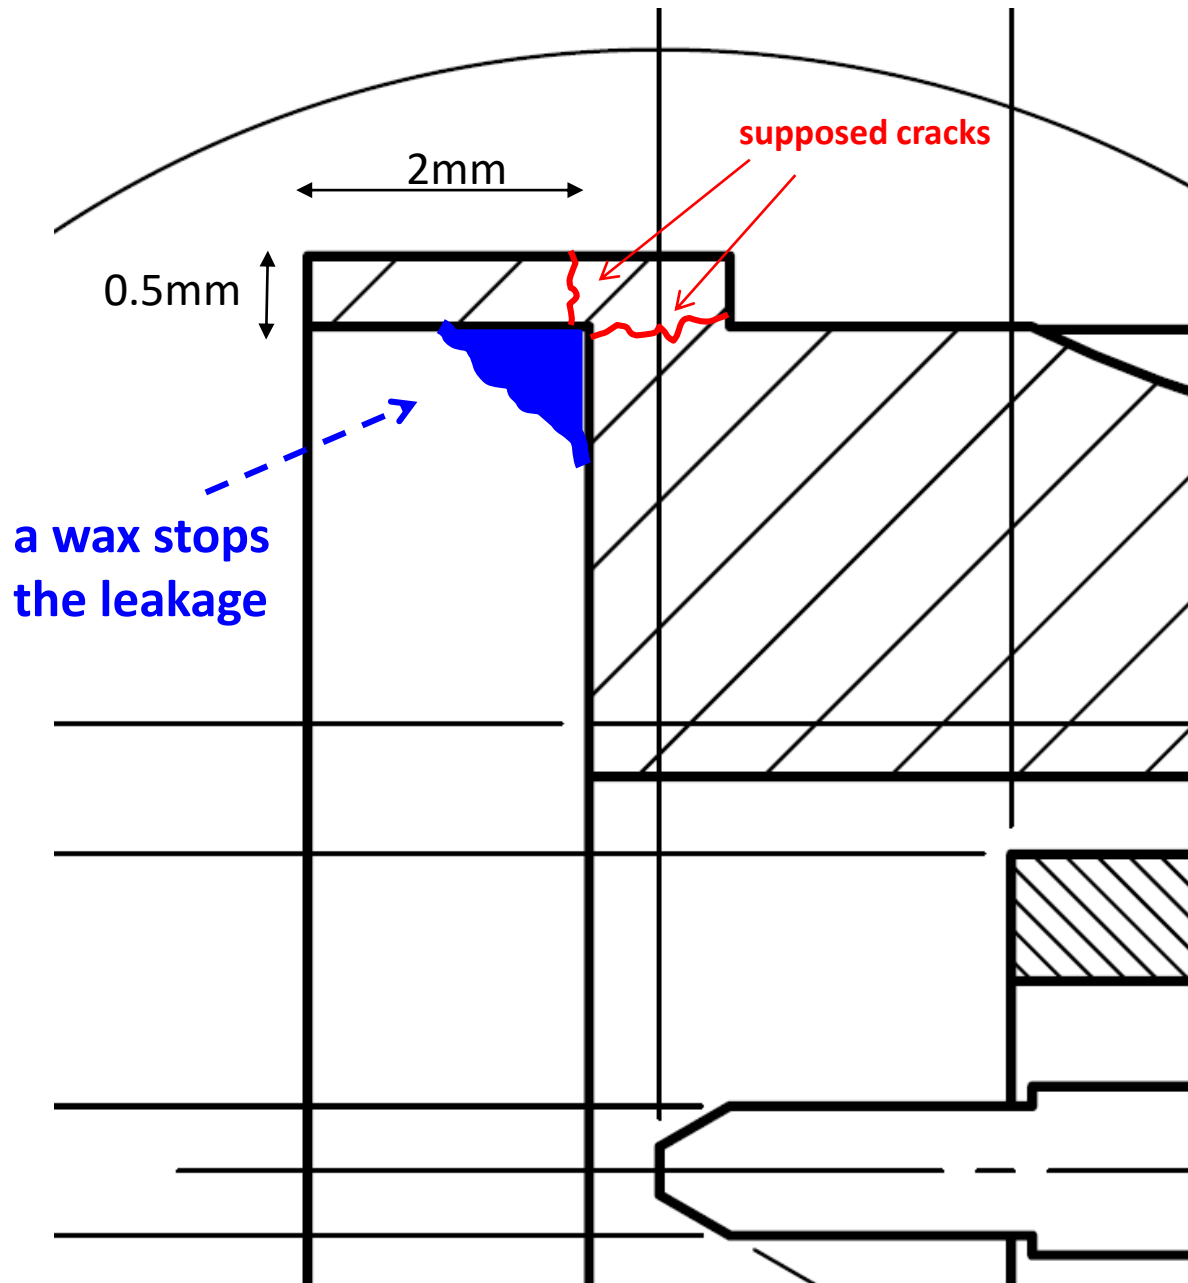
vacuum wax applied :
the leak is stopped !

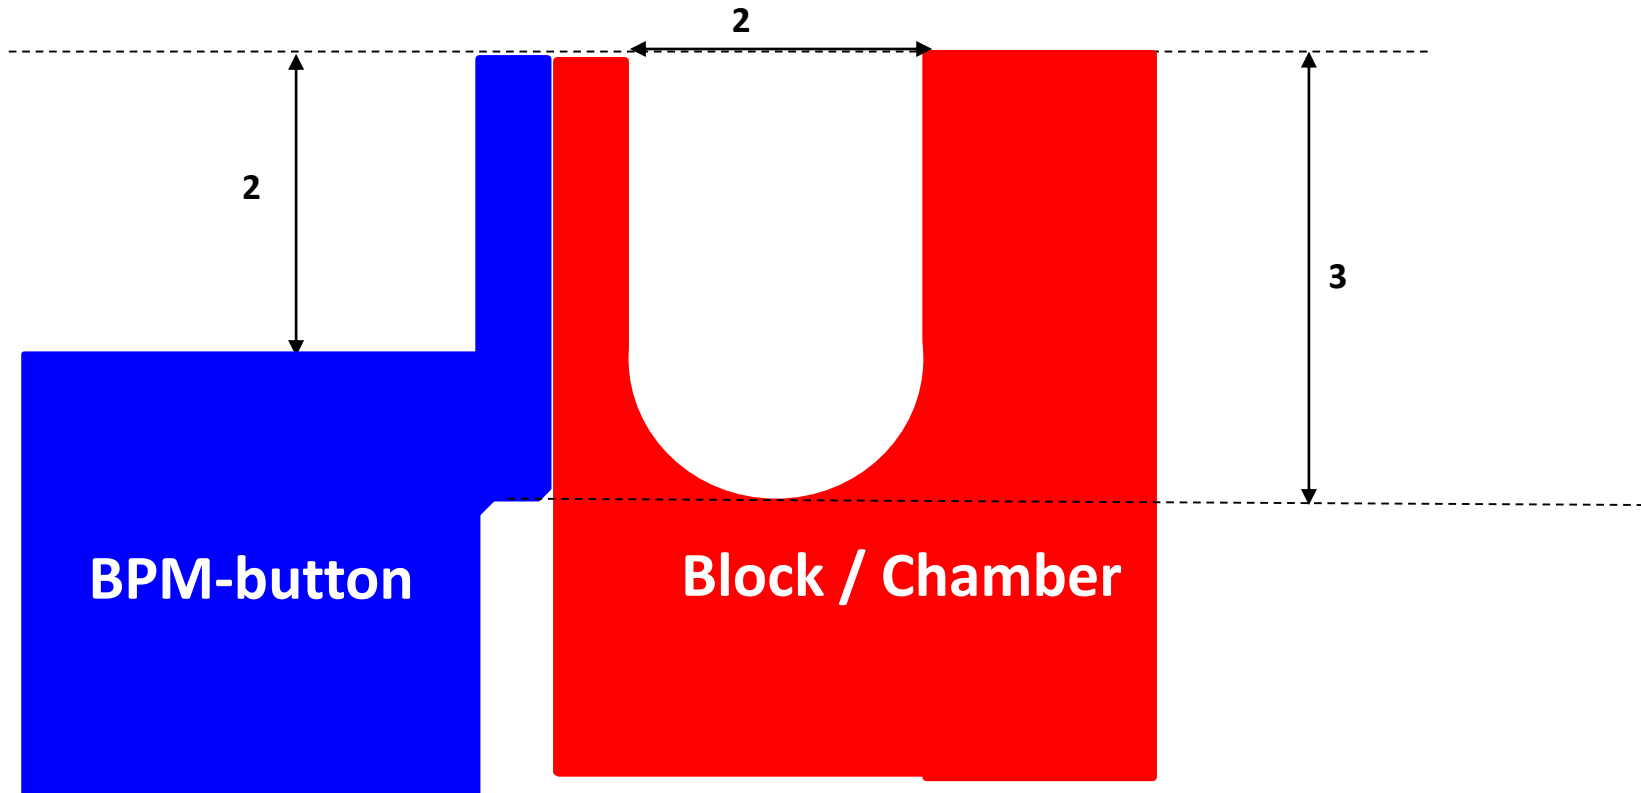
**FMB proposal for different lip
on the block/hole side**

FMB experience (Jan-April) : 2 failures out of 24 ...

more rigourous test (May) : 5 failures out of 60 ...

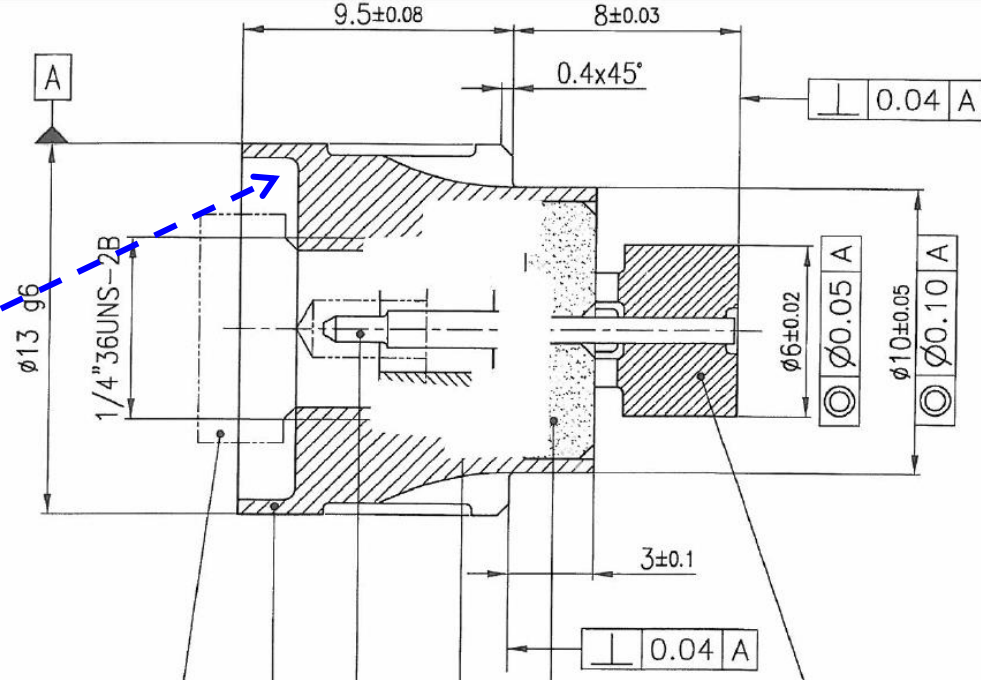
DLS

rounded corners

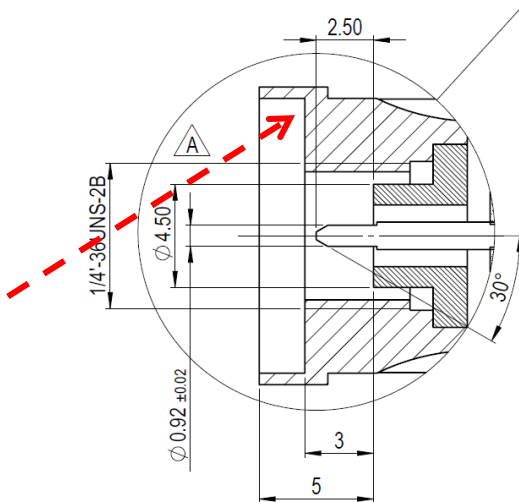
ESRF

sharp corners

lecon :
do NOT indicate sharp-corners
unless you really need them

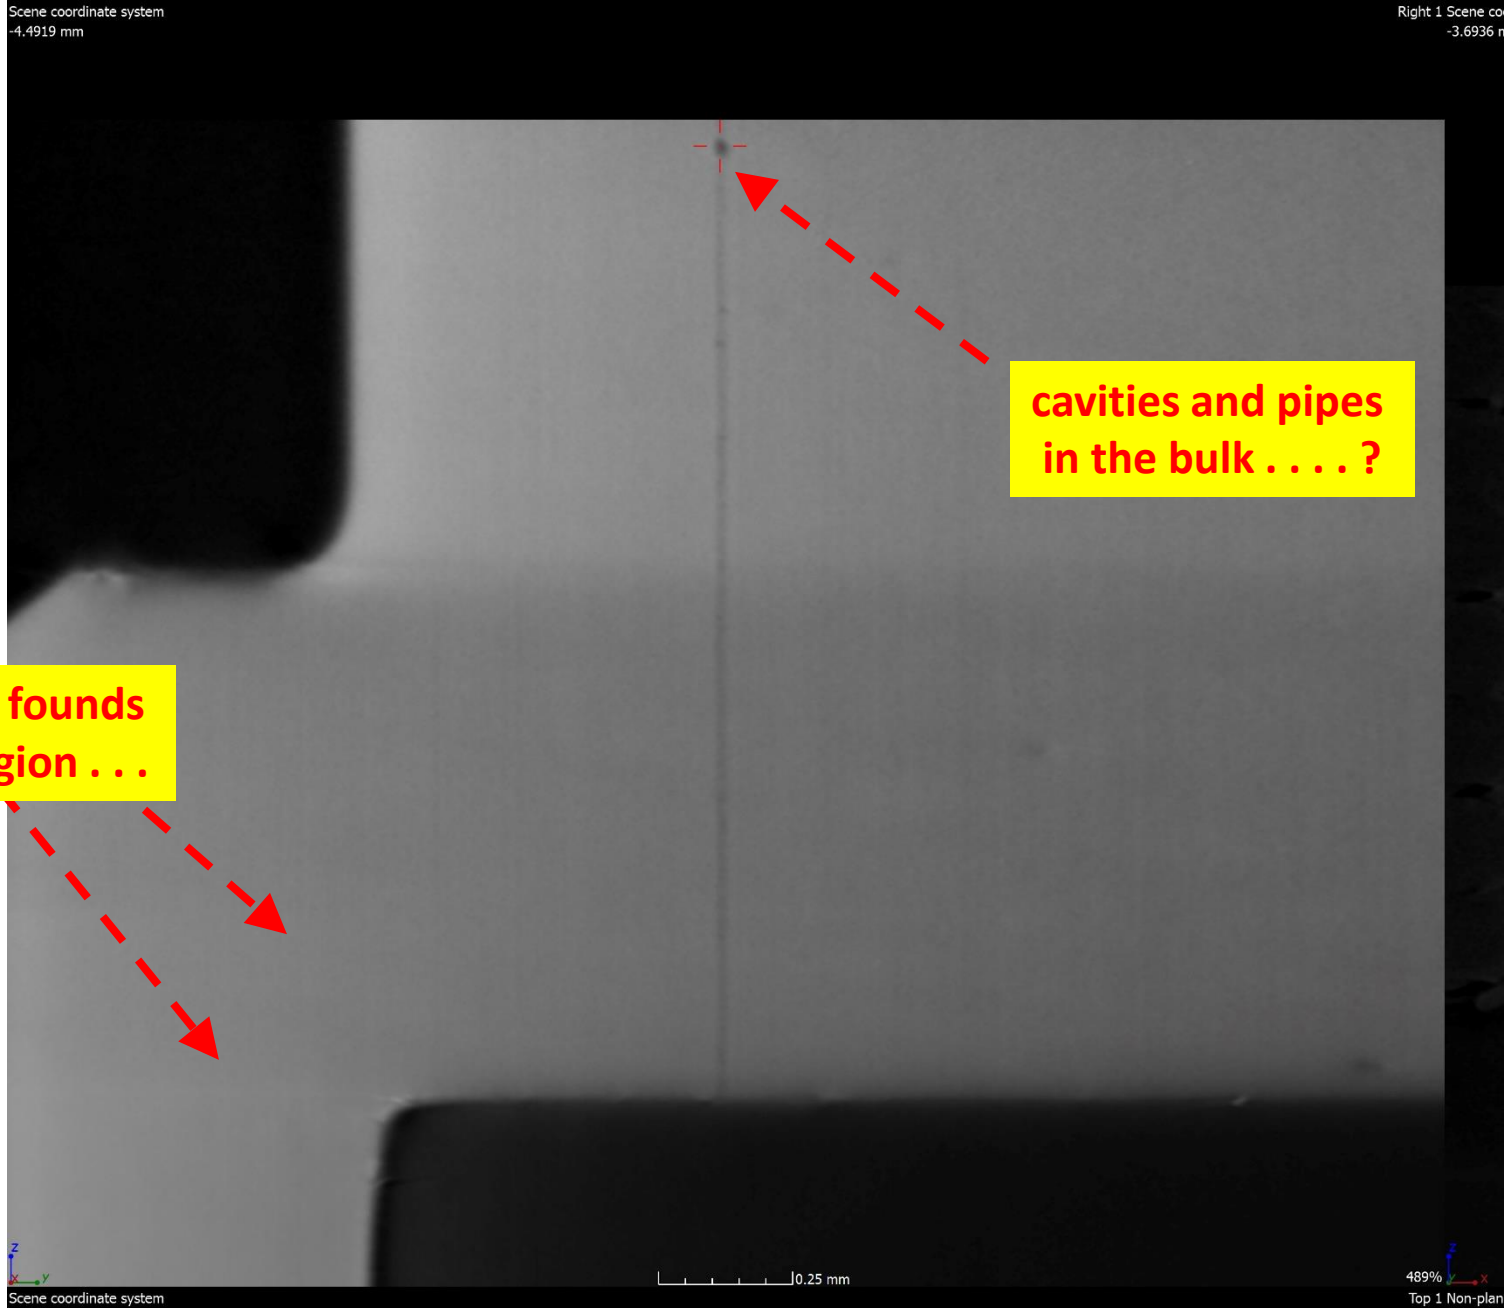
X-ray tomography done at a dedicated ESRF beamline on a leaking BPM-button :

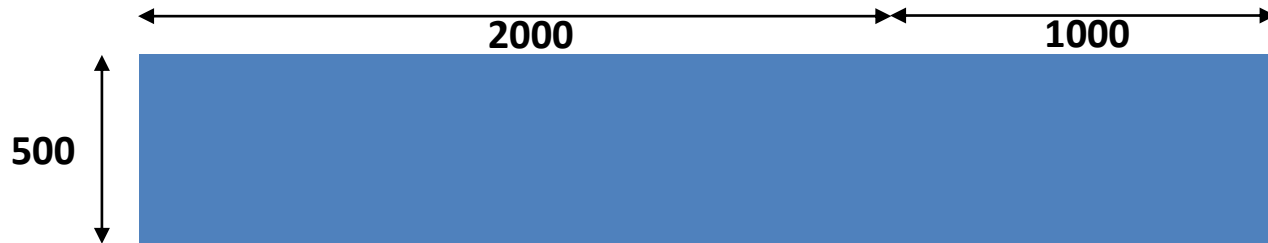
with groove :

in red what will be removed

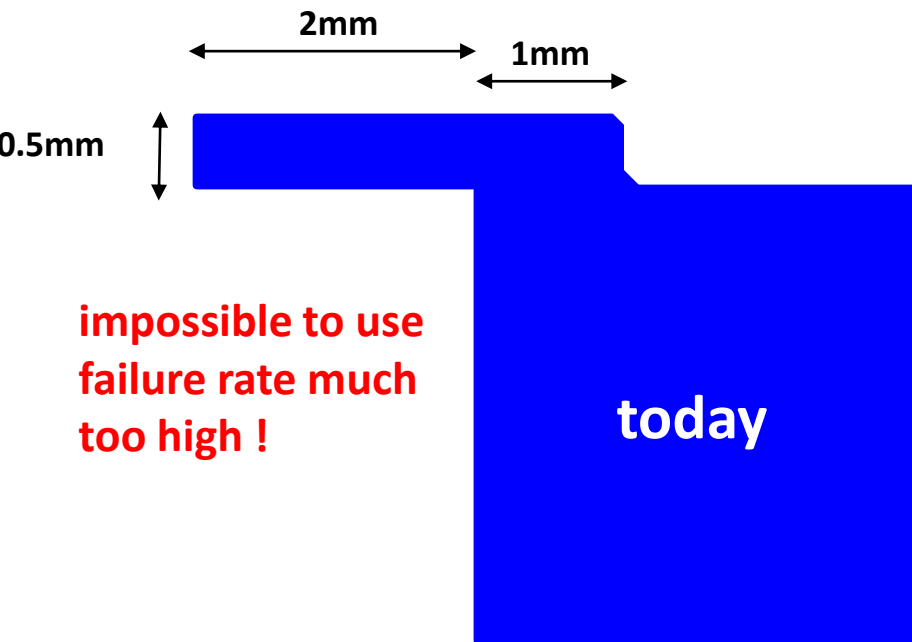
now :

impossible to use
failure rate much
too high !

tests to be done in July
on 60 units

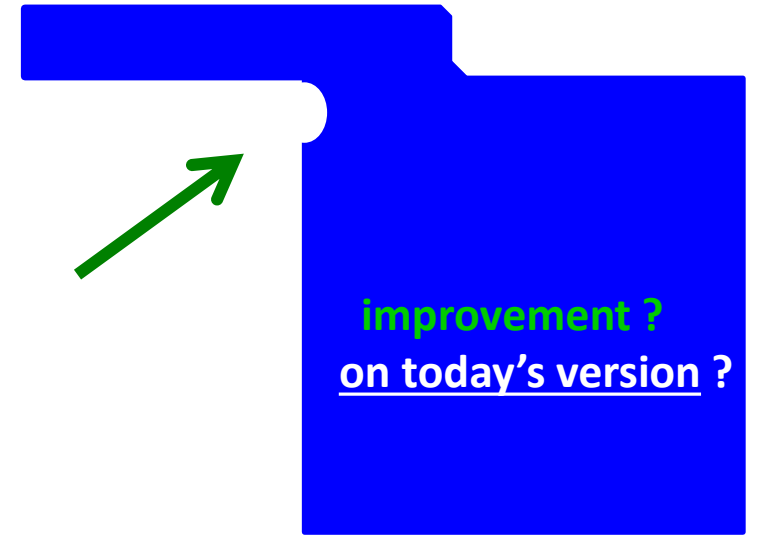
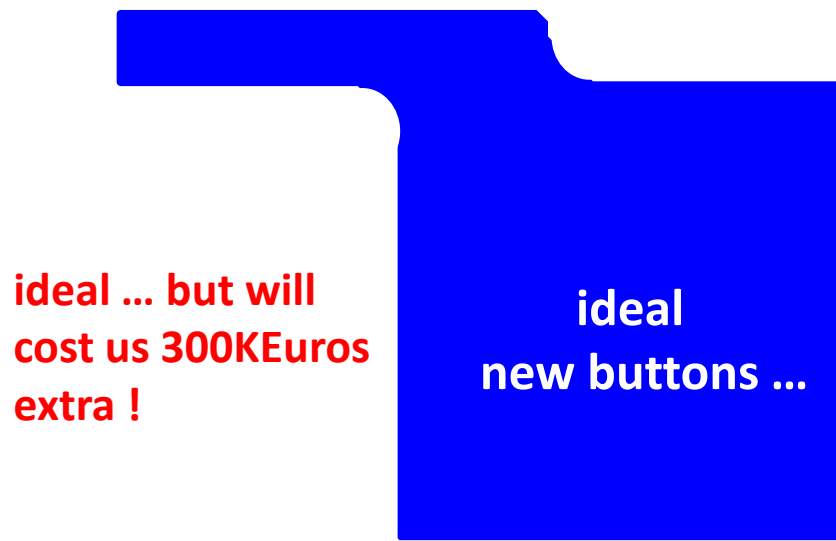
ideal ... but will
cost us 300KEuros
extra !
