UHV leakage problems with the new EBS-ESRF-BPM buttons

ESRF-EBS

Extremely Brilliant Source

BPM-button vacuum leaks

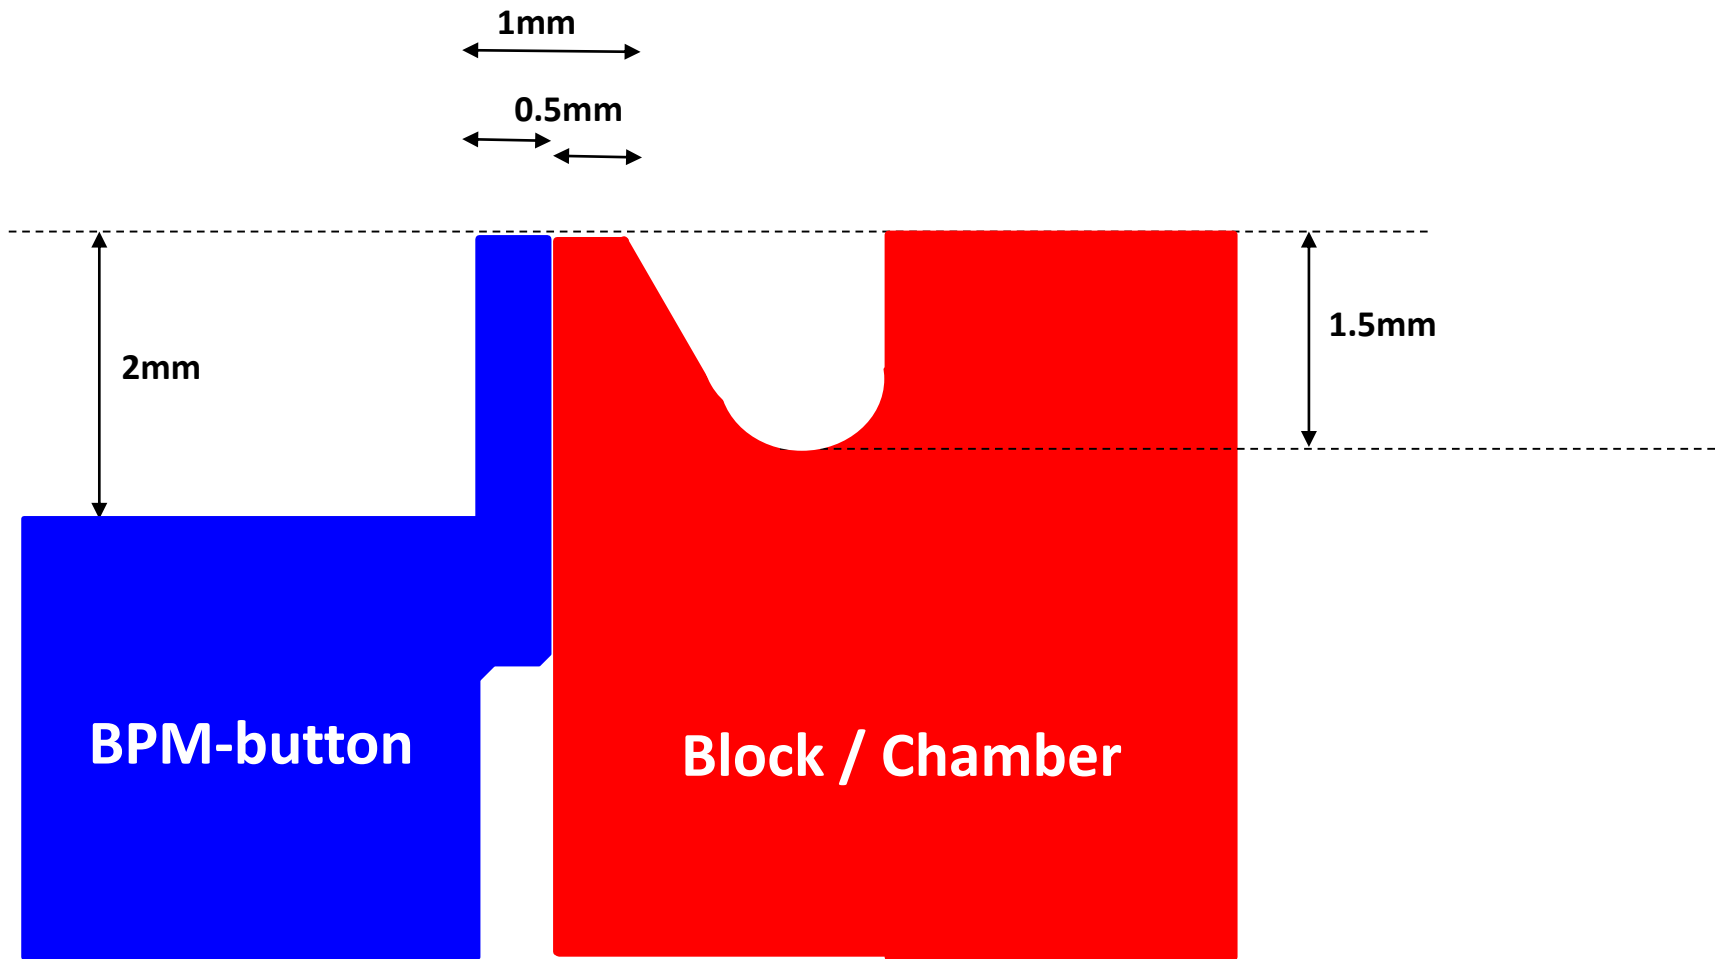
**FMB experience (December) : 4 failures out of 16 buttons welded
→ 25% failure-rate !**

vacuum wax applied : the leak is stopped !

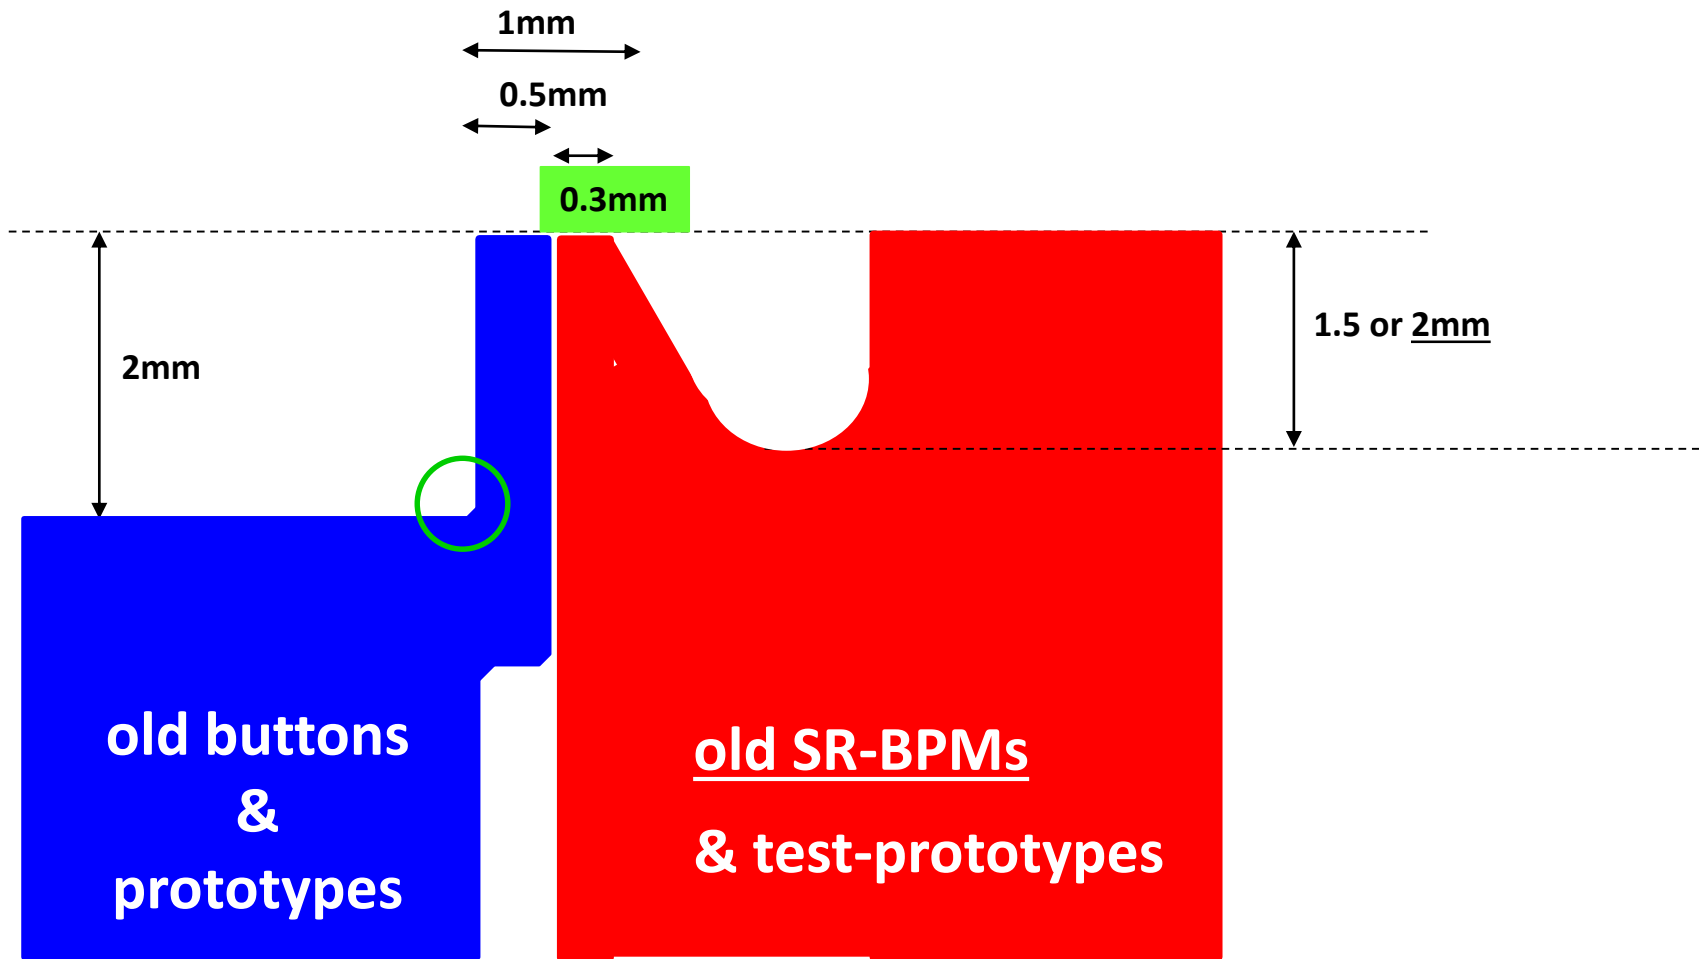
old buttons / BPMs : never any leaks (SR- & SY- >1300)

the 12 protos : no leaks

**FMB proposal for different lip
on the block/hole side**

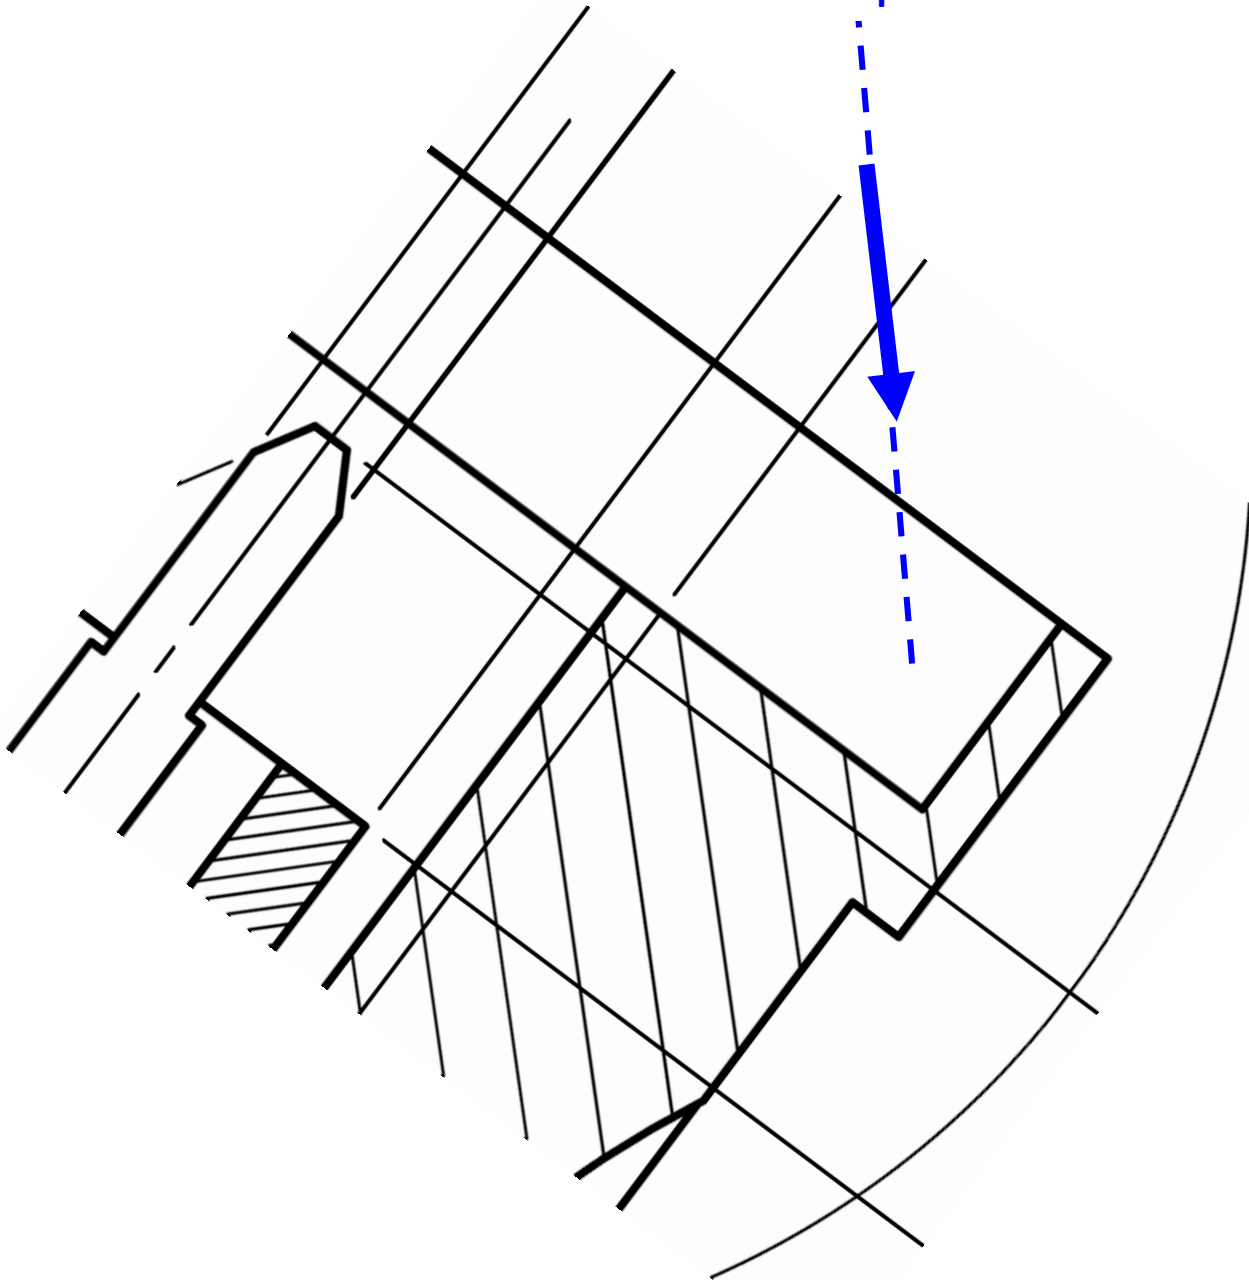
angle of view
micro-scope

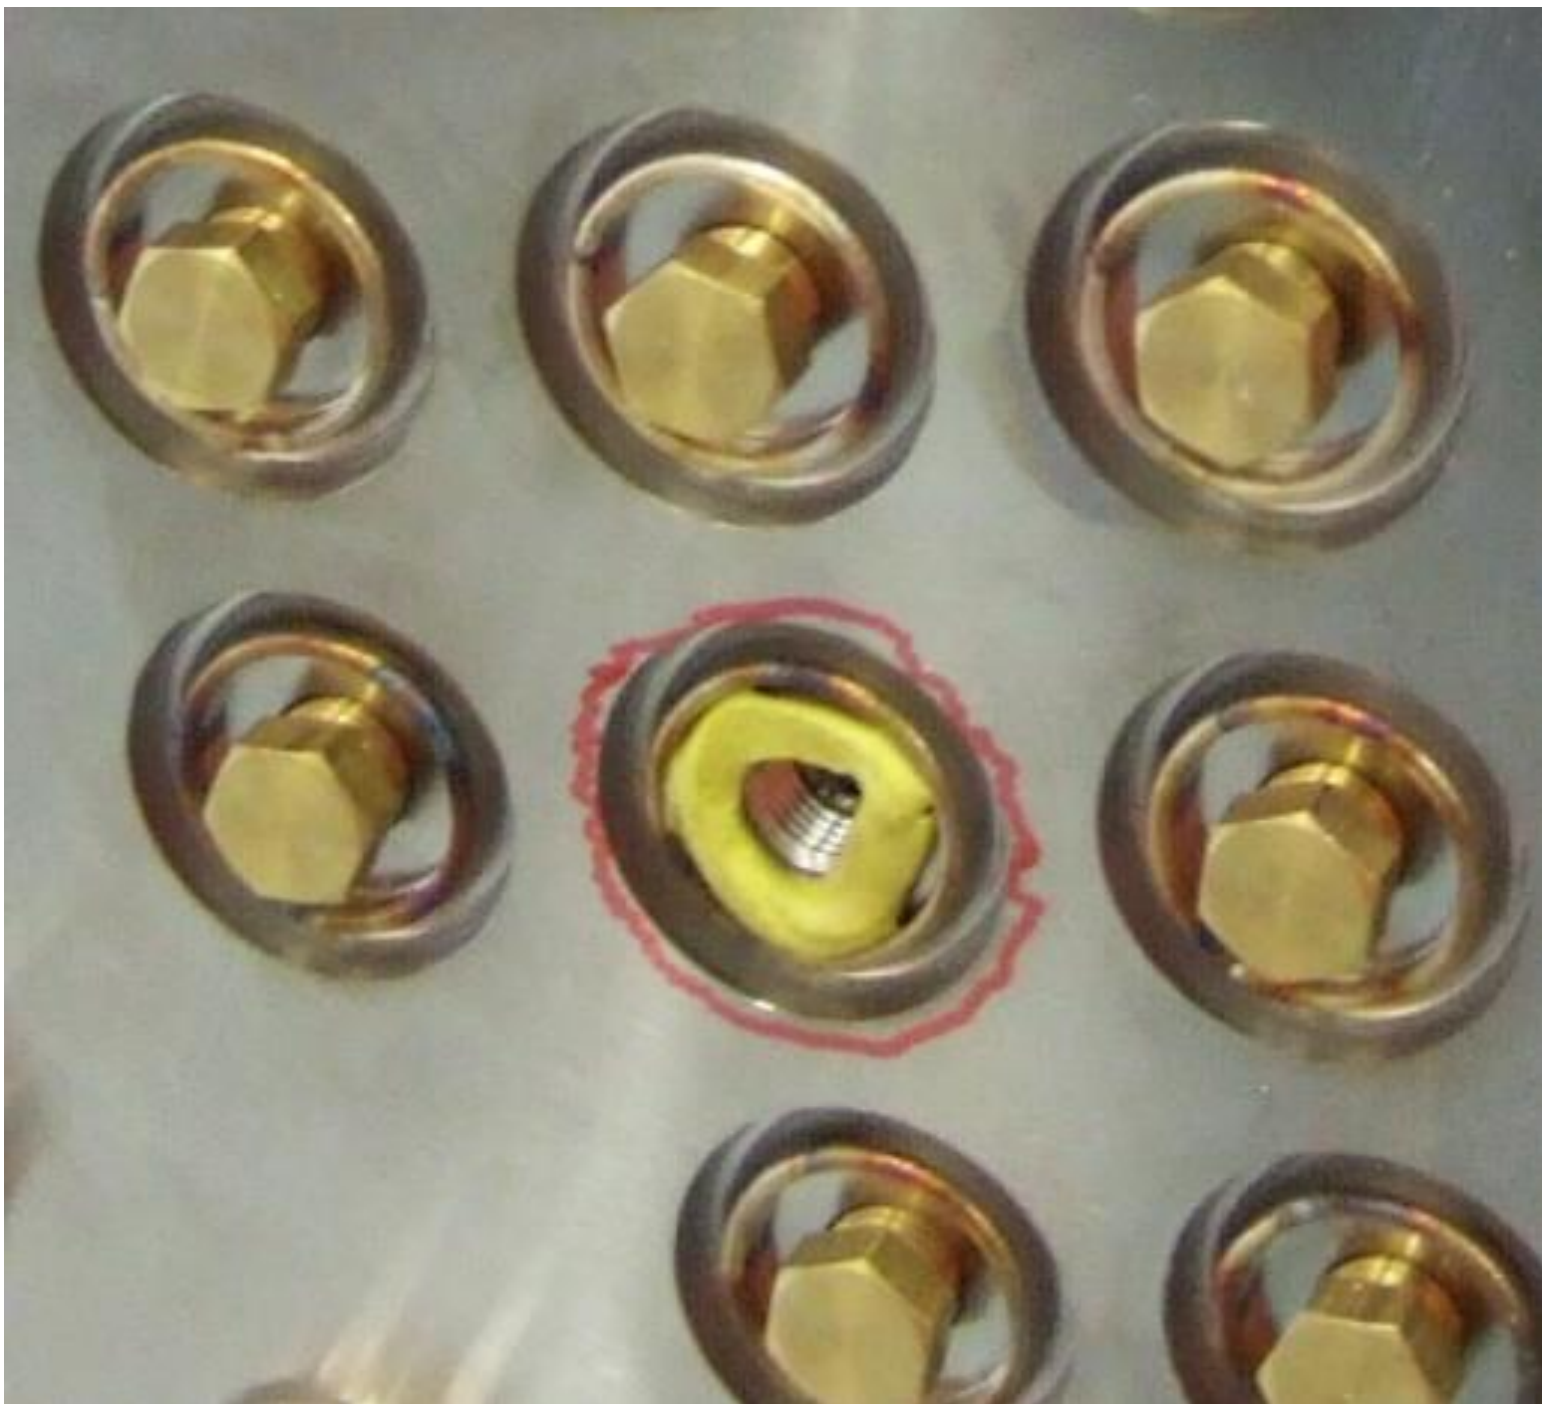
30 BPMs in one
CF150 flange

done 2 x
so **60 units** tested
→ **5 leaks**

the leaking spots
are confirmed to
be in the lip-corner
